Manhole Inspection Summary

Manhole # S35KK_043MH

Location Address: **1732 SAINT PAUL ST**

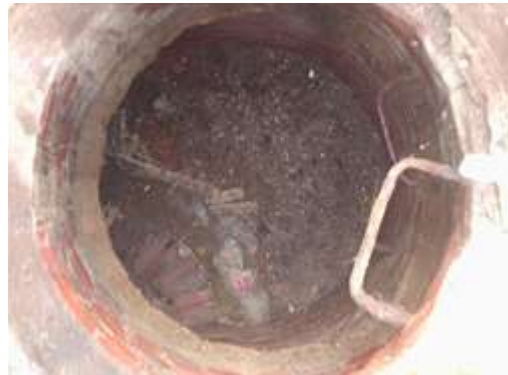
Top View

Corroded steps. Evidence of surcharge - Bench debris. Channel debris.

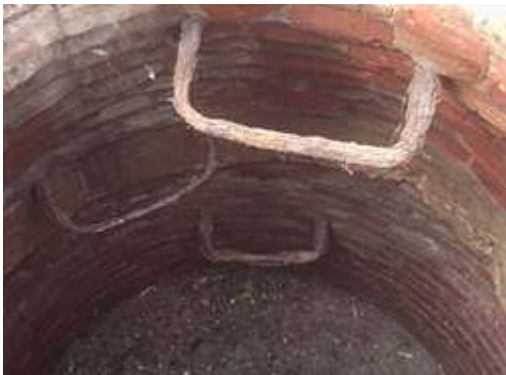
Defect

Corbel and Barrel infiltration.

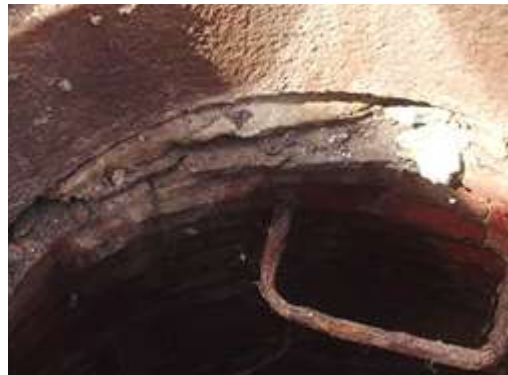
Defect

Frame leaks. Adjustment deterioration and infiltration.

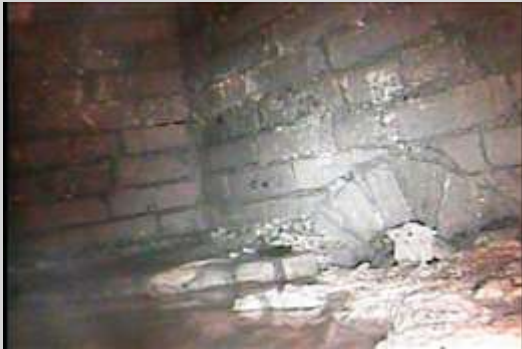
8 in. Circular Gravity Sewer Pipe Out @ 12 O'Clock

Deposits: ☐ None ☐ **Mud** ☐ Sludge ☒ **Debris** ☒ **Grease**

Silt Depth: **6** (in.) Deposits Extent: **Heavy**

Infiltration: **Evidence** Pipe Seal Cond: **Unknown**

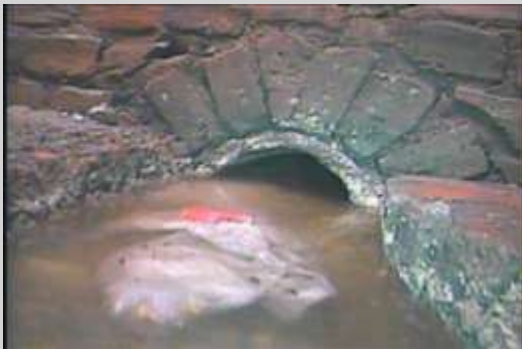
8 in. Circular Gravity Sewer Pipe In @ 6 O'Clock

Barrel deterioration and infiltration.

Deposits: ☐ None ☒ **Mud** ☐ Sludge ☒ **Debris** ☒ **Grease**

Silt Depth: **3** (in.) Deposits Extent: **Medium**

Infiltration: **Evidence** Pipe Seal Cond: **Unknown**

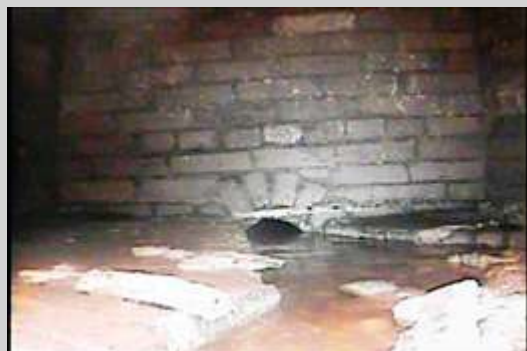
Pipe In @ 9 O'Clock

Deposits: ☐ None ☒ **Mud** ☐ Sludge ☒ **Debris** ☒ **Grease**

Silt Depth: **1** (in.)

Deposits Extent: **Light**
